New York State Department of Transportation

Yellow Flag NB2358W014

BIN: 1065318

Location: Span 242, Girder G1 at Pier 242

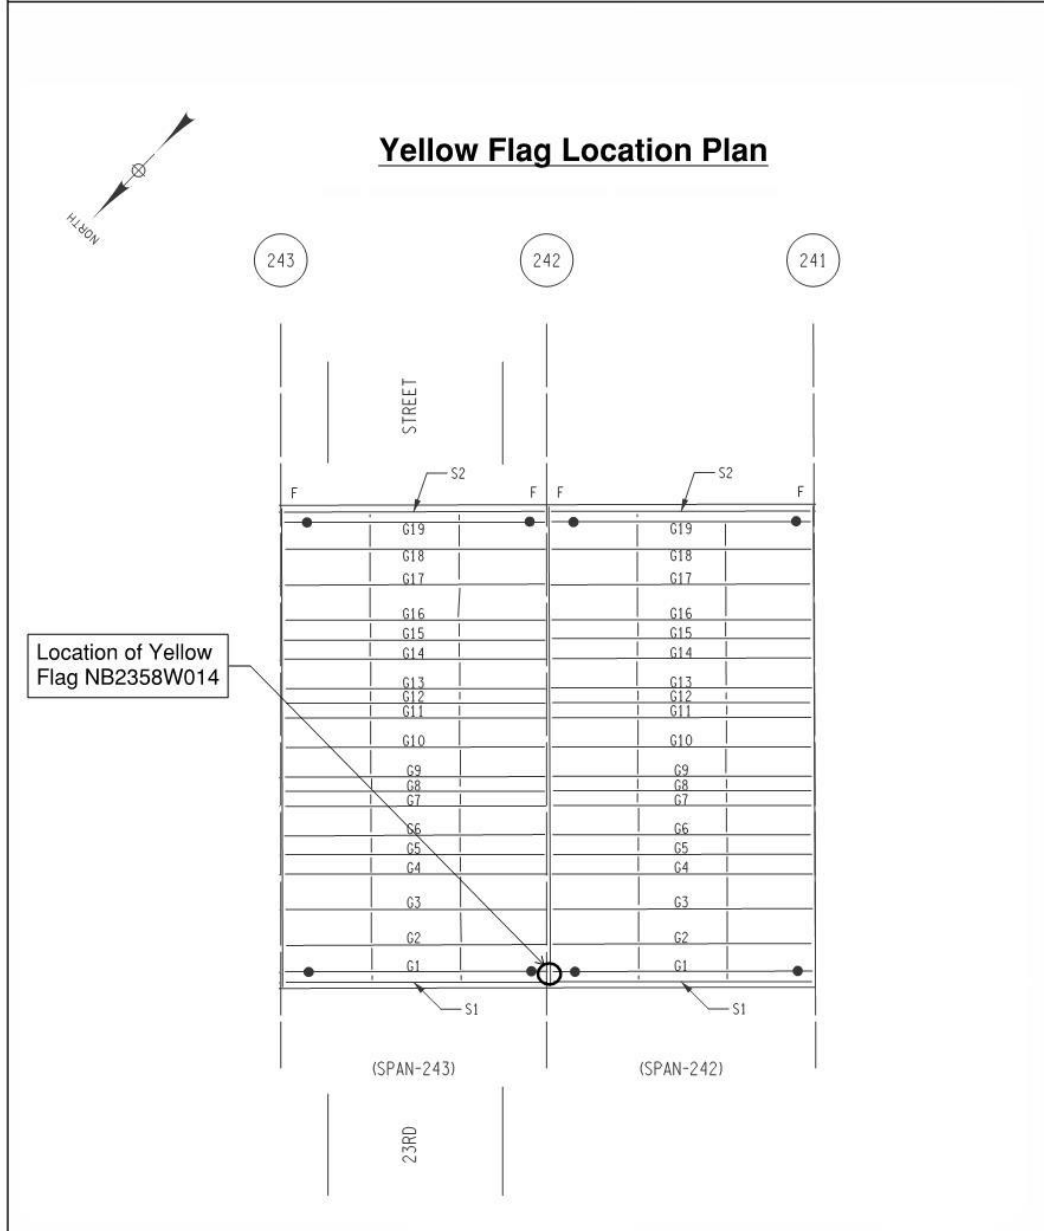
Flag PhotographsPhoto Number: **1**Photo Filename: **23_Flag Location Plan.jpg**Gowanus Expressway
2023 Biennial Inspection - Field SketchBIN: 1065318Team: AA/TSDate: 05/31/2023Span: 242Location: Girder G1 at Pier 242

**wsp****Attachment Description: Flag Location Plan**

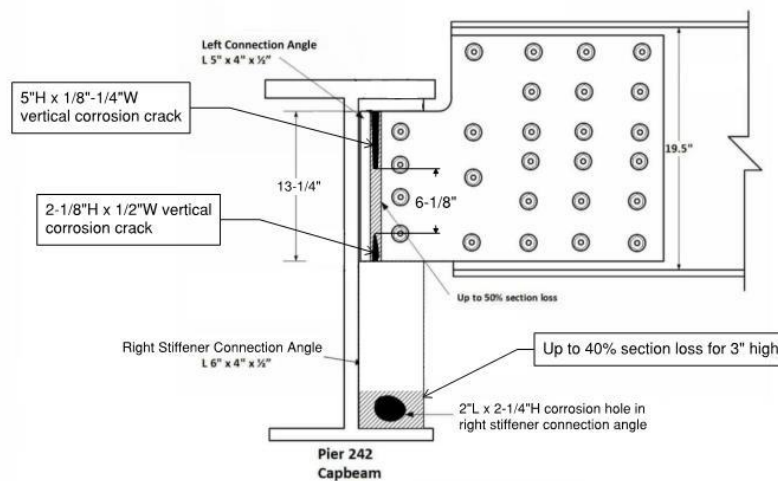
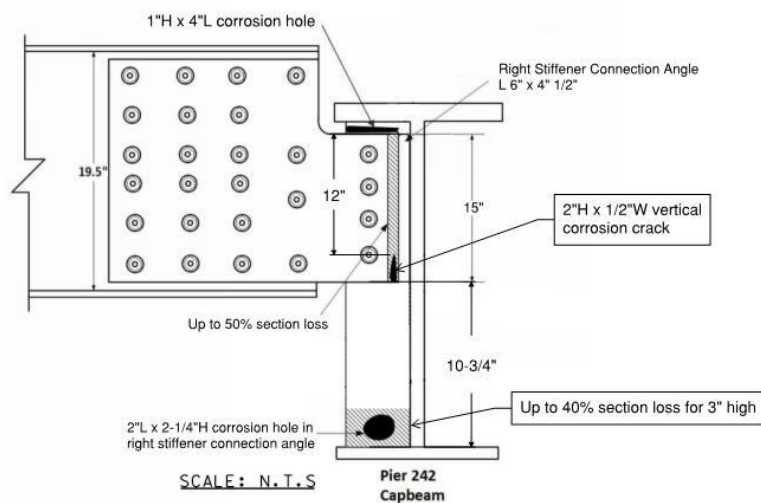
Photo Number: 2

(refer to Yellow Flag Condition Sketch Photo #2 for more details)

-As-measured web thickness is approximately 0.606"

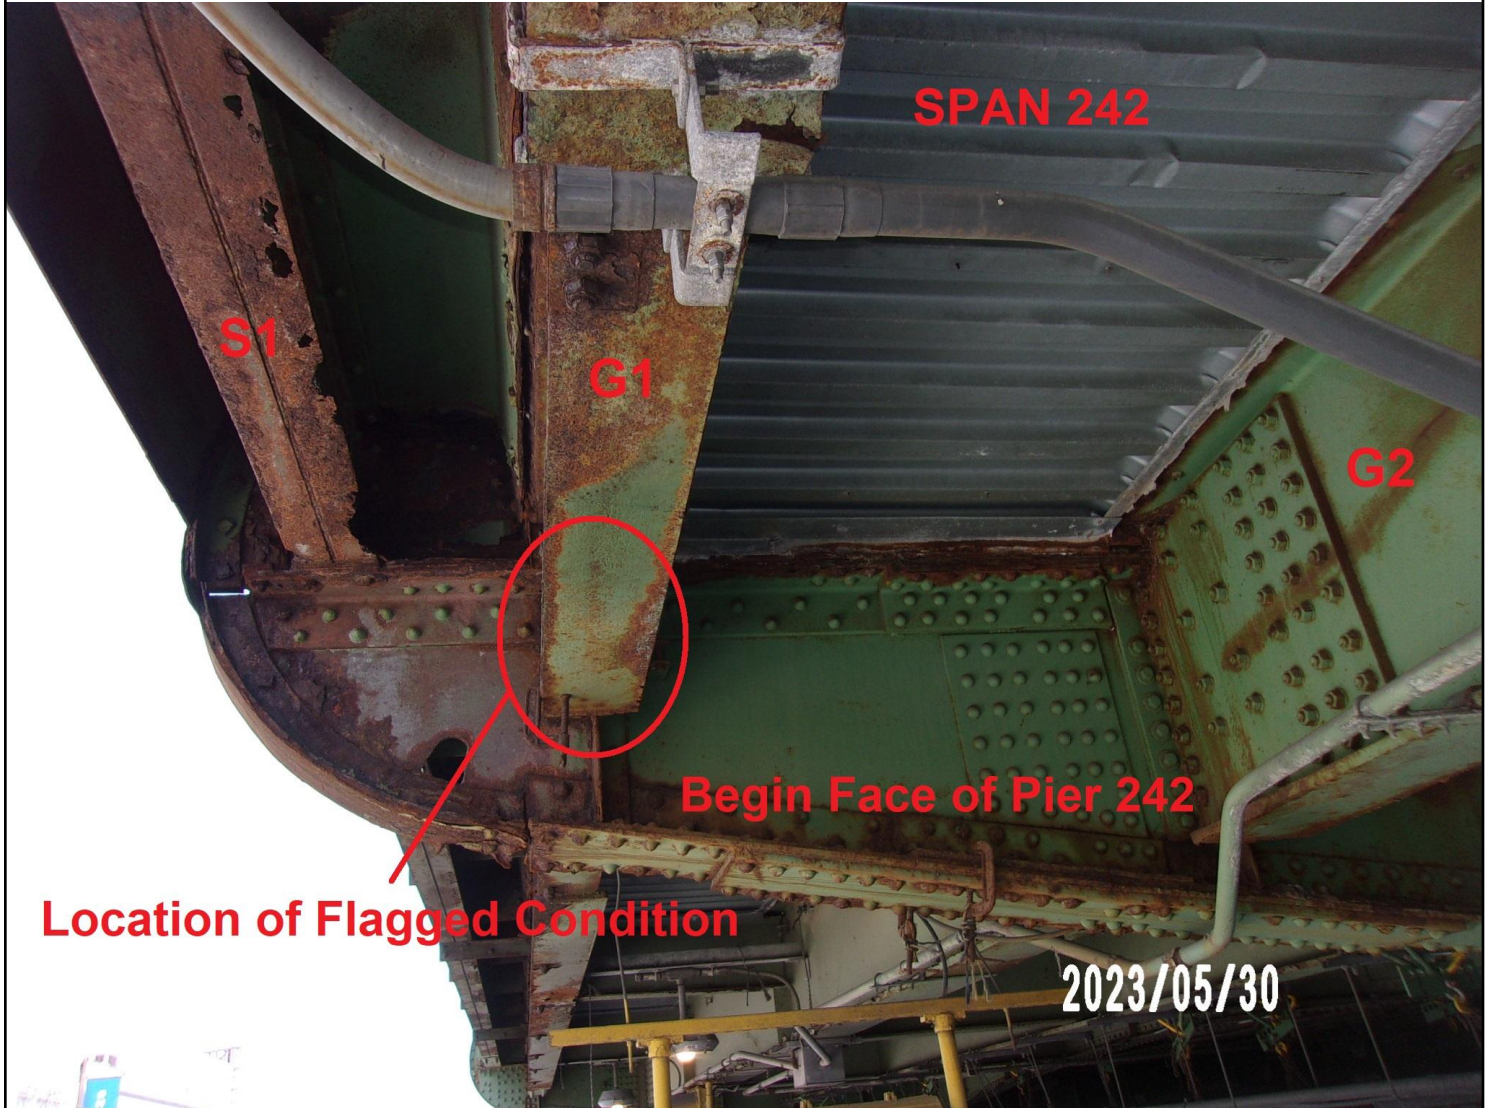
Photo Number: 3

Attachment Description: General view of the flagged condition at Girder G1 in Span 242 at Pier 242. Looking End.

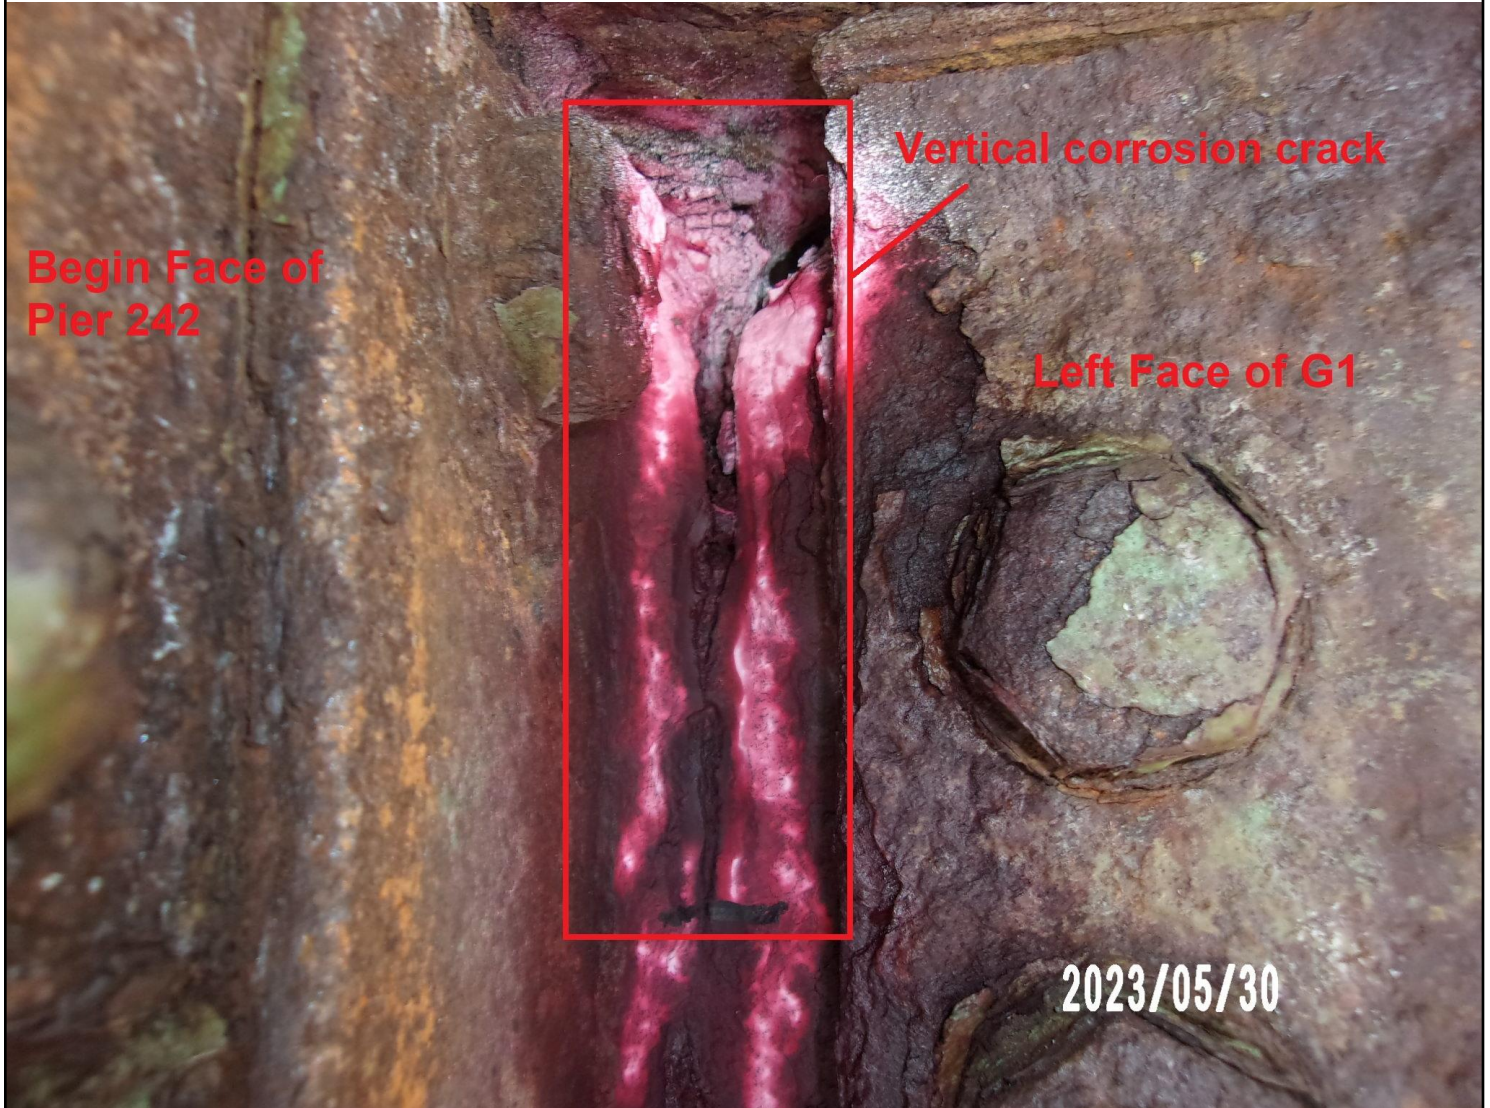
Photo Number: 4

The left connection angle at Girder G1 connection to the pier cap at Pier 242 exhibits a 2-1/8"H x 1/2"W (no changes since previous inspection) vertical corrosion crack at the lower fillet section (Photo 5) and 5"H x 1/8"-1/4"W (previously 2-3/4"H x 1"W) corrosion crack at the upper fillet section (Photo 4). The remaining 6-1/8" area of the fillet section between the corrosion cracks at the top and bottom of the angle exhibits up to 50% section loss (Photo 6).

Attachment Description: The left face of Girder G1 in Span 242 at Pier 242. The top of the left connection angle exhibits 5"H x 1/8"-1/4"W corrosion crack at the fillet section. Looking Right.

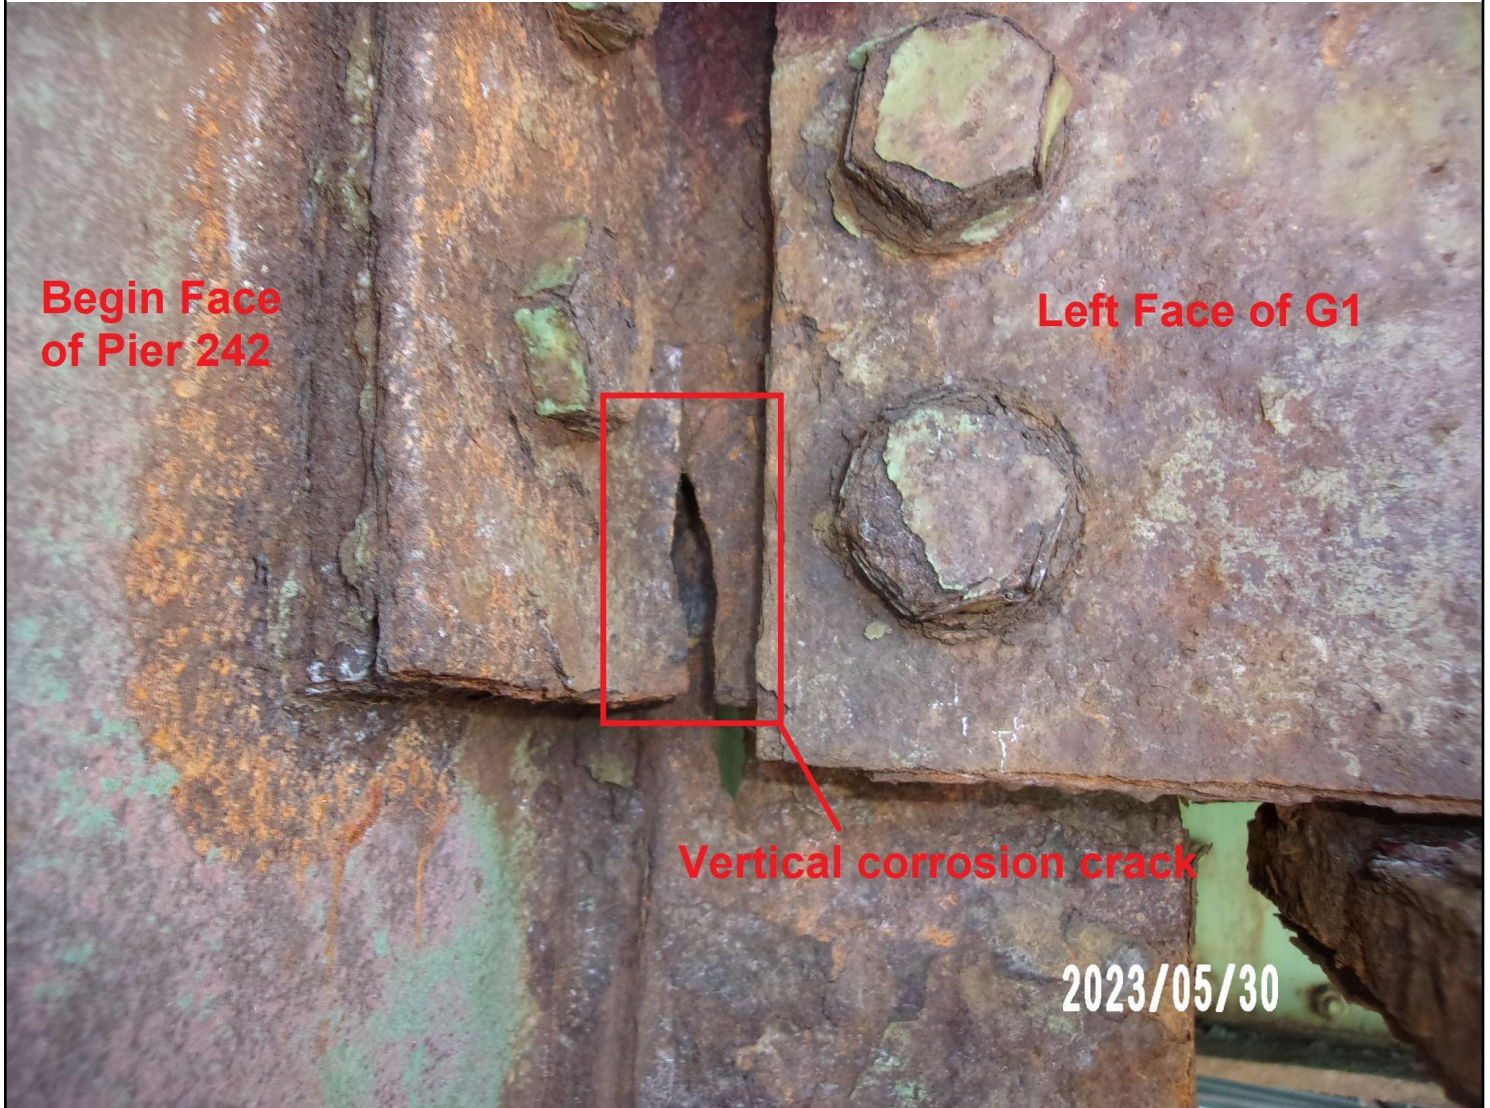
Photo Number: 5

Attachment Description: The left face of Girder G1 in Span 242 at Pier 242. The bottom of the left connection angle exhibits 2-1/8"H x 1/2"W corrosion crack at the fillet section. Looking Right.

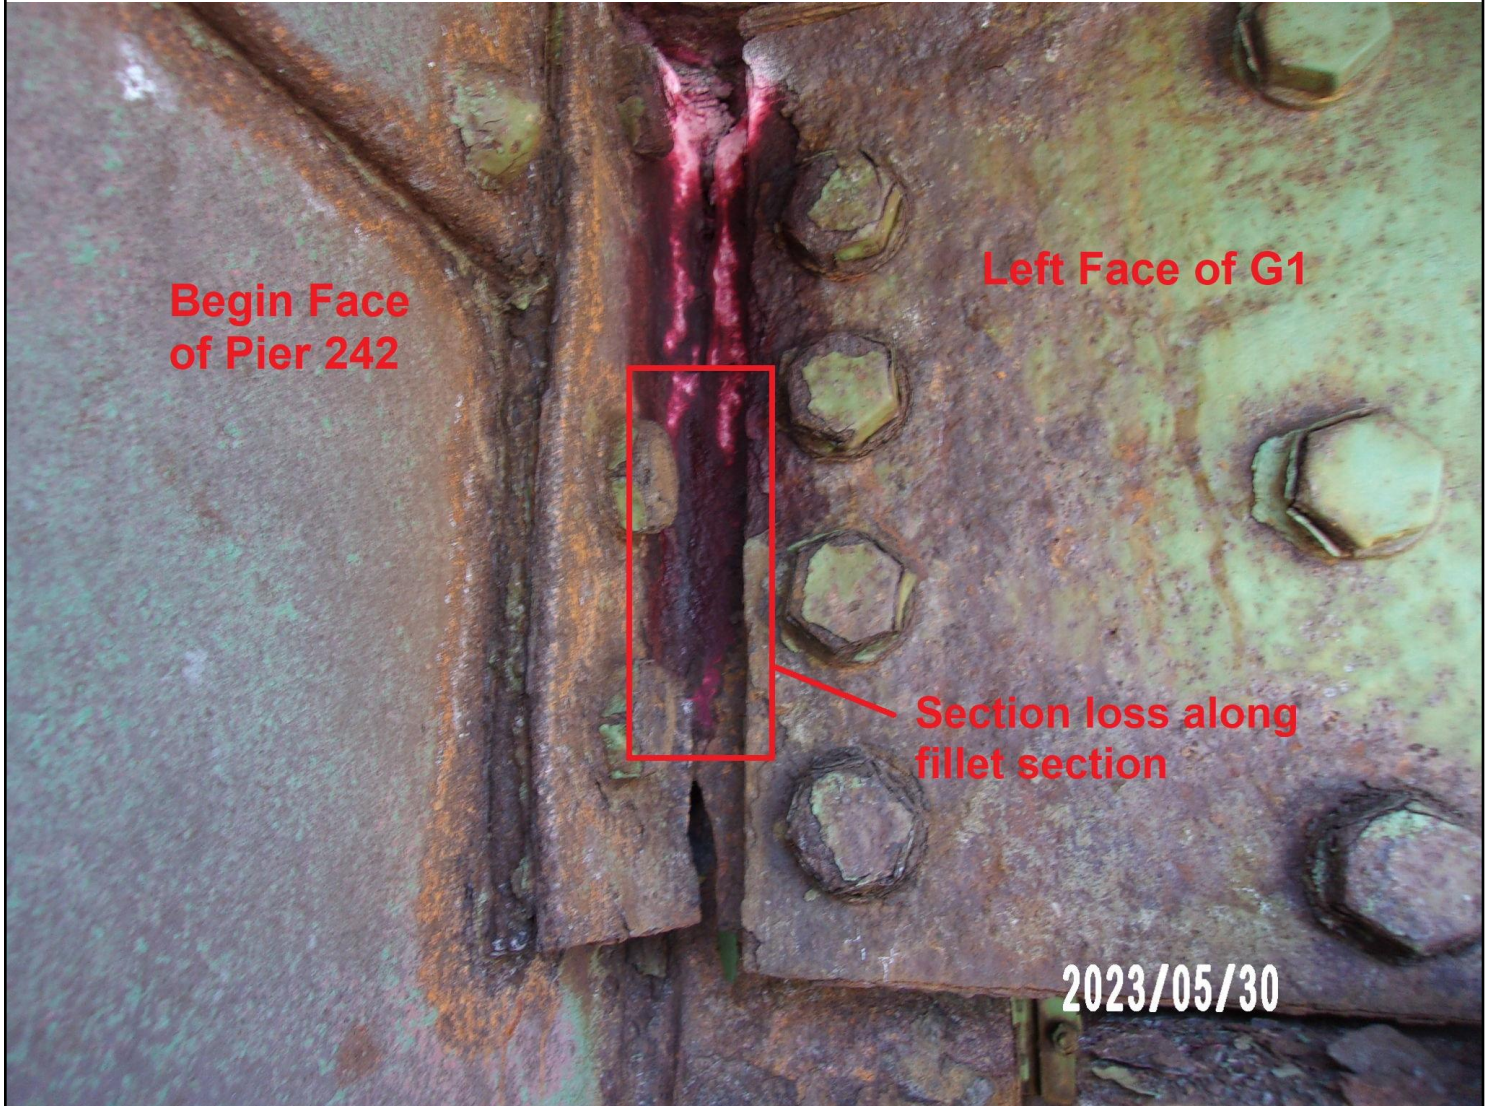
Photo Number: 6

Attachment Description: The left face of Girder G1 in Span 242 at Pier 242. The left connection angle exhibits up to 50% section loss in the fillet section between cracks at the top and bottom of angle. Looking Right.

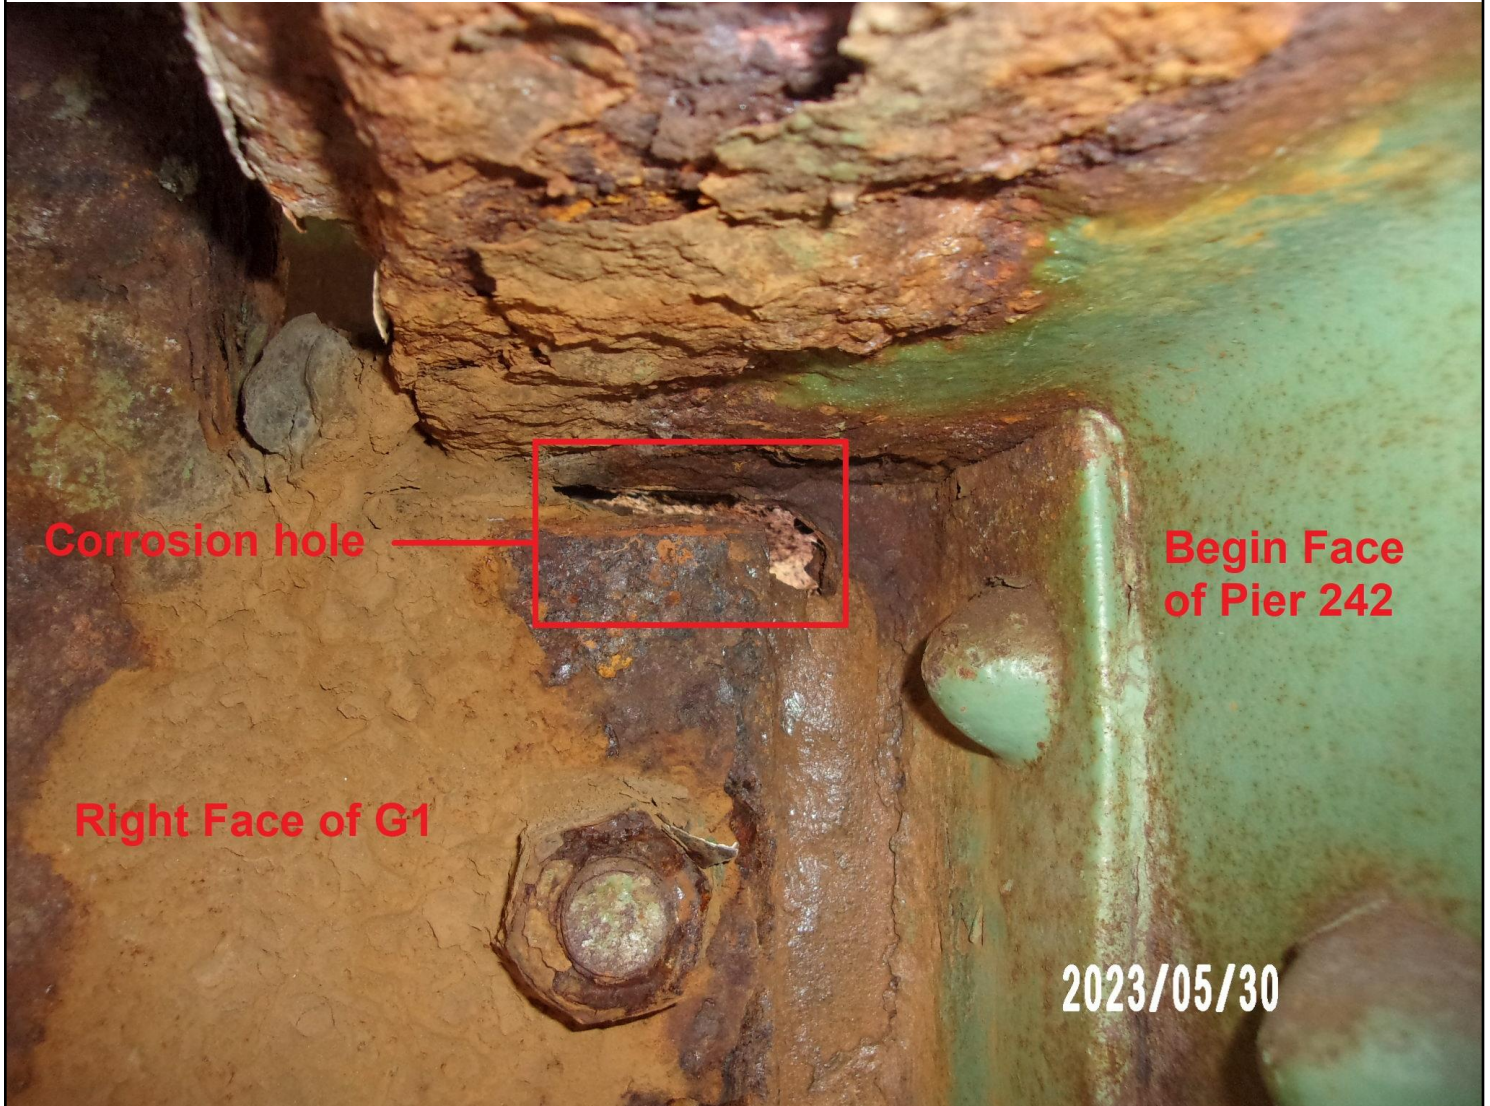
Photo Number: 7

The right stiffener connection angle exhibits a 2"H x 1/2"W (no changes since previous inspection) vertical corrosion crack at the lower fillet section (Photo 8), 1"H x 4"L corrosion hole (no changes since previous inspection) in the top of the stiffener connection angle adjacent to the fillet section (Photo 7), and 2-1/4"H x 2"L corrosion hole (no changes since the previous inspection) at the base of the stiffener connection angle (Photo 10). The remaining 12" area of the fillet section between the corrosion hole and crack at the top and bottom of the angle exhibits up to 50% section loss (Photo 9). The base of the stiffener connection angle above the pier bottom flange exhibits up to 40% section loss for 3" high surrounding the corrosion hole (Photo 10).

Attachment Description: The right face of Girder G1 in Span 242 at Pier 242. The top of the right stiffener connection angle exhibits 1"H x 4"L corrosion hole. Looking Left.

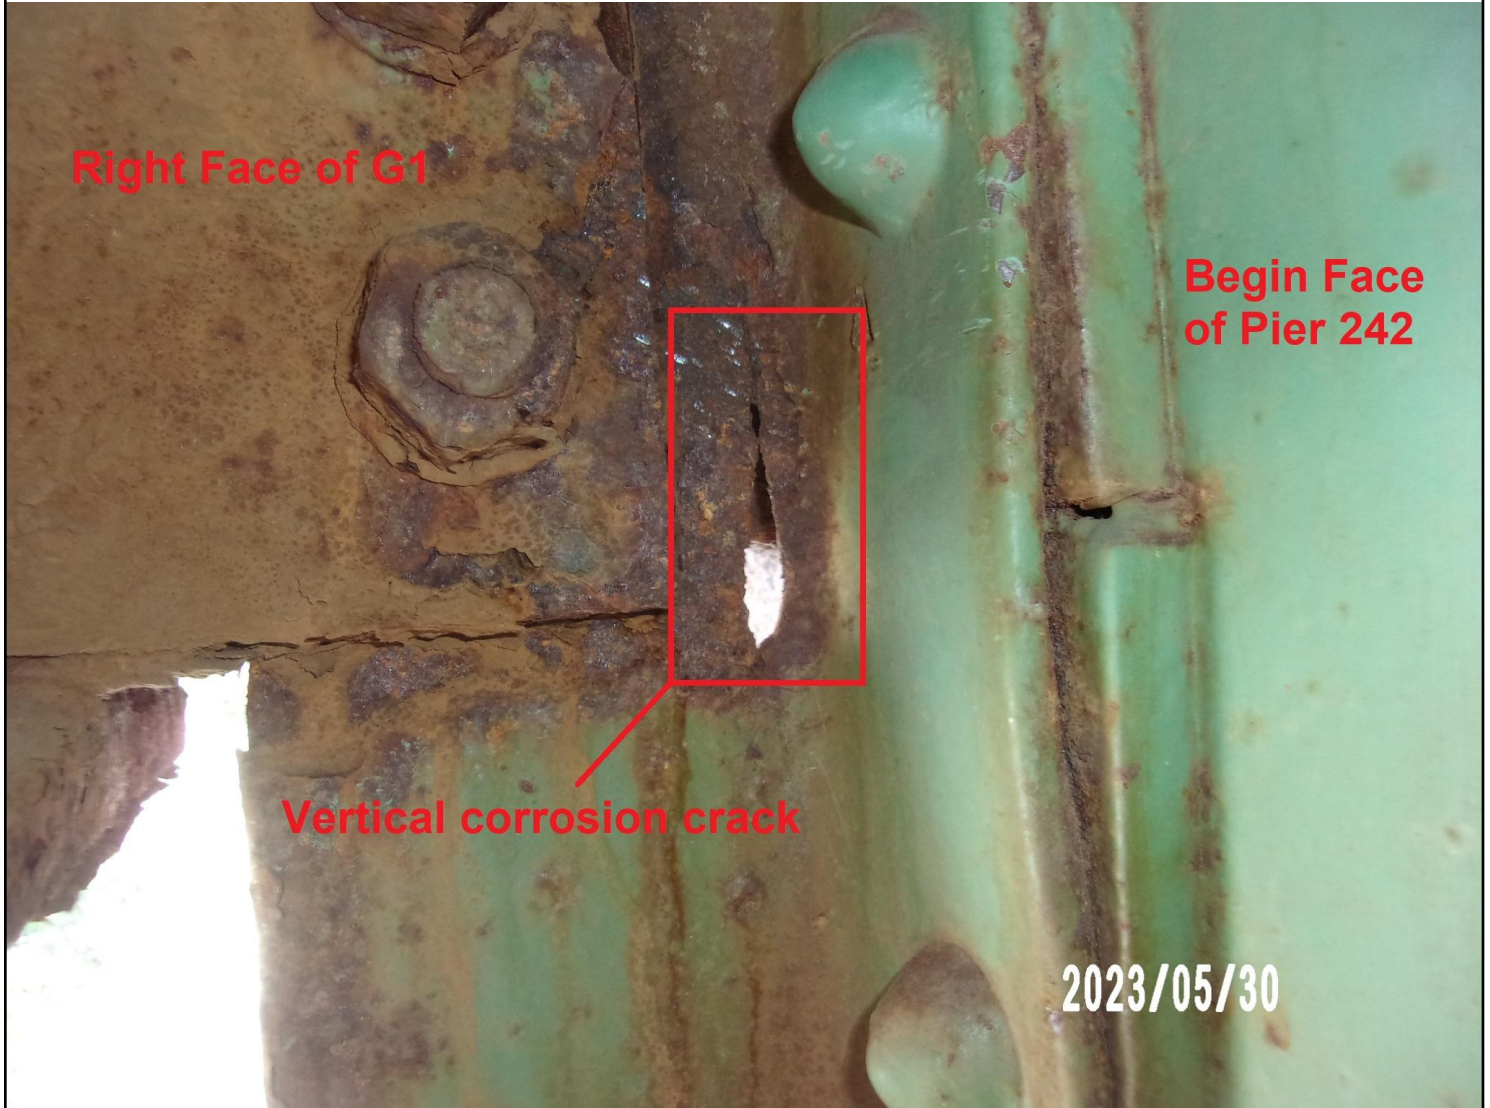
Photo Number: 8

Attachment Description: The right face of Girder G1 in Span 242 at Pier 242. The bottom of the right stiffener connection angle exhibits 2"H x 1/2"W corrosion crack at the fillet section. Looking Left.

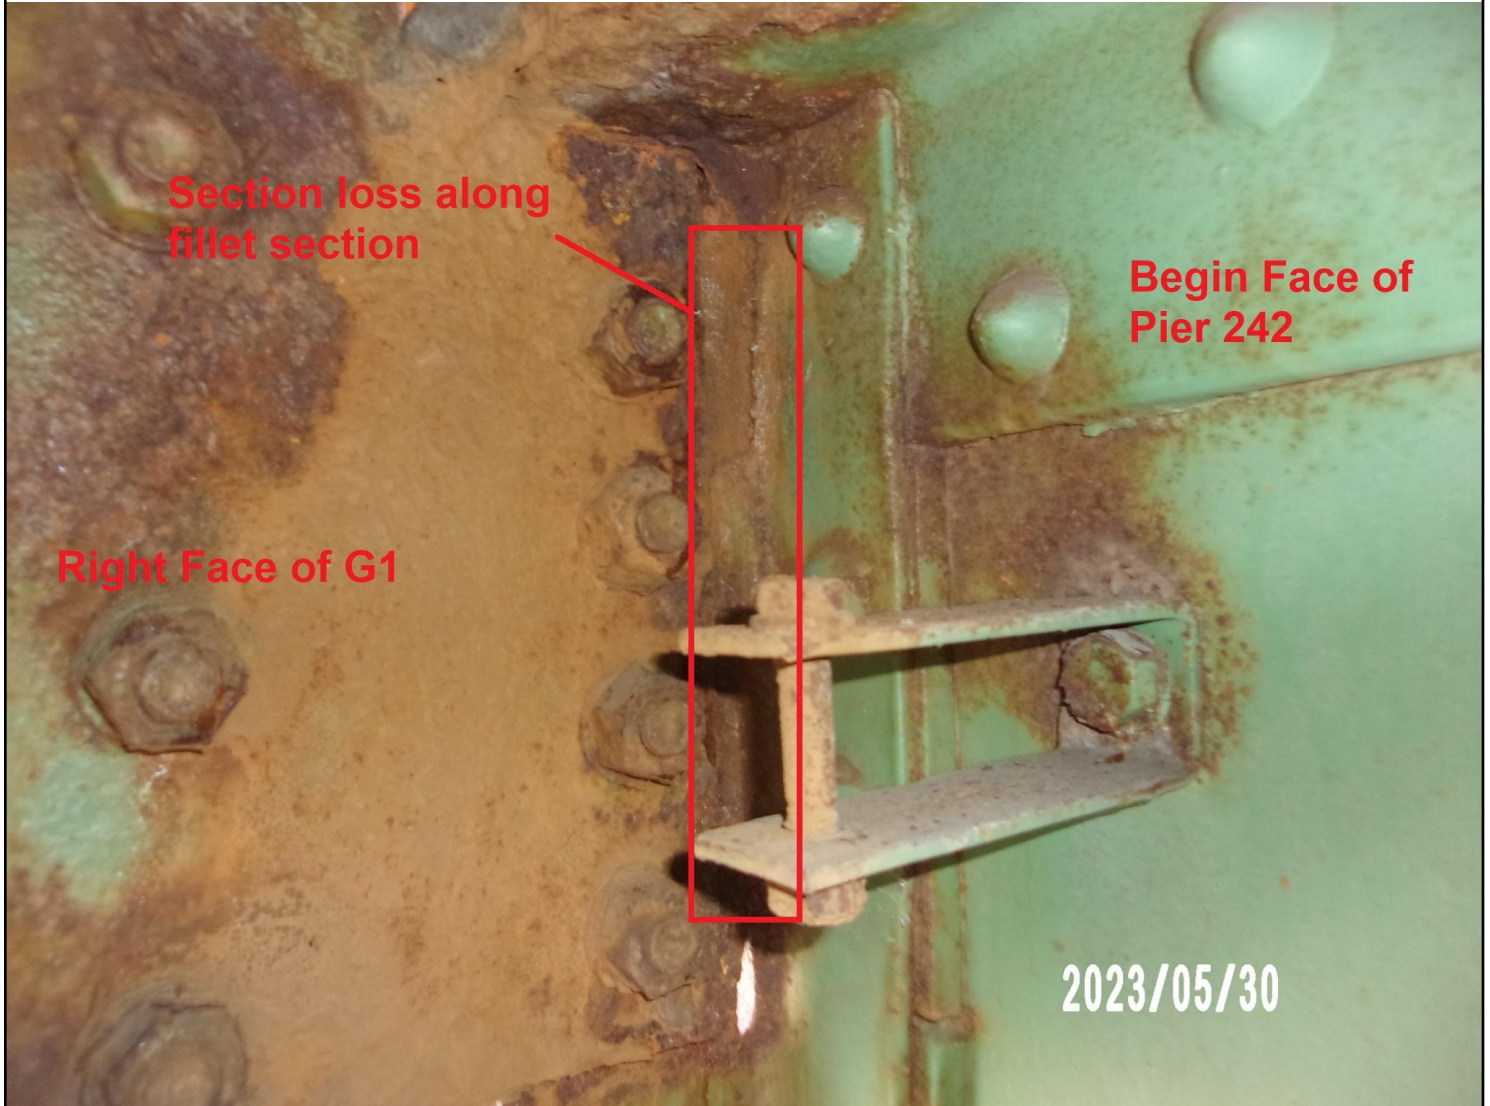
Photo Number: 9

Attachment Description: The right face of Girder G1 in Span 242 at Pier 242. The right stiffener connection angle exhibits up to 50% section loss in the fillet section between hole at the top and crack at the bottom. Looking Left.

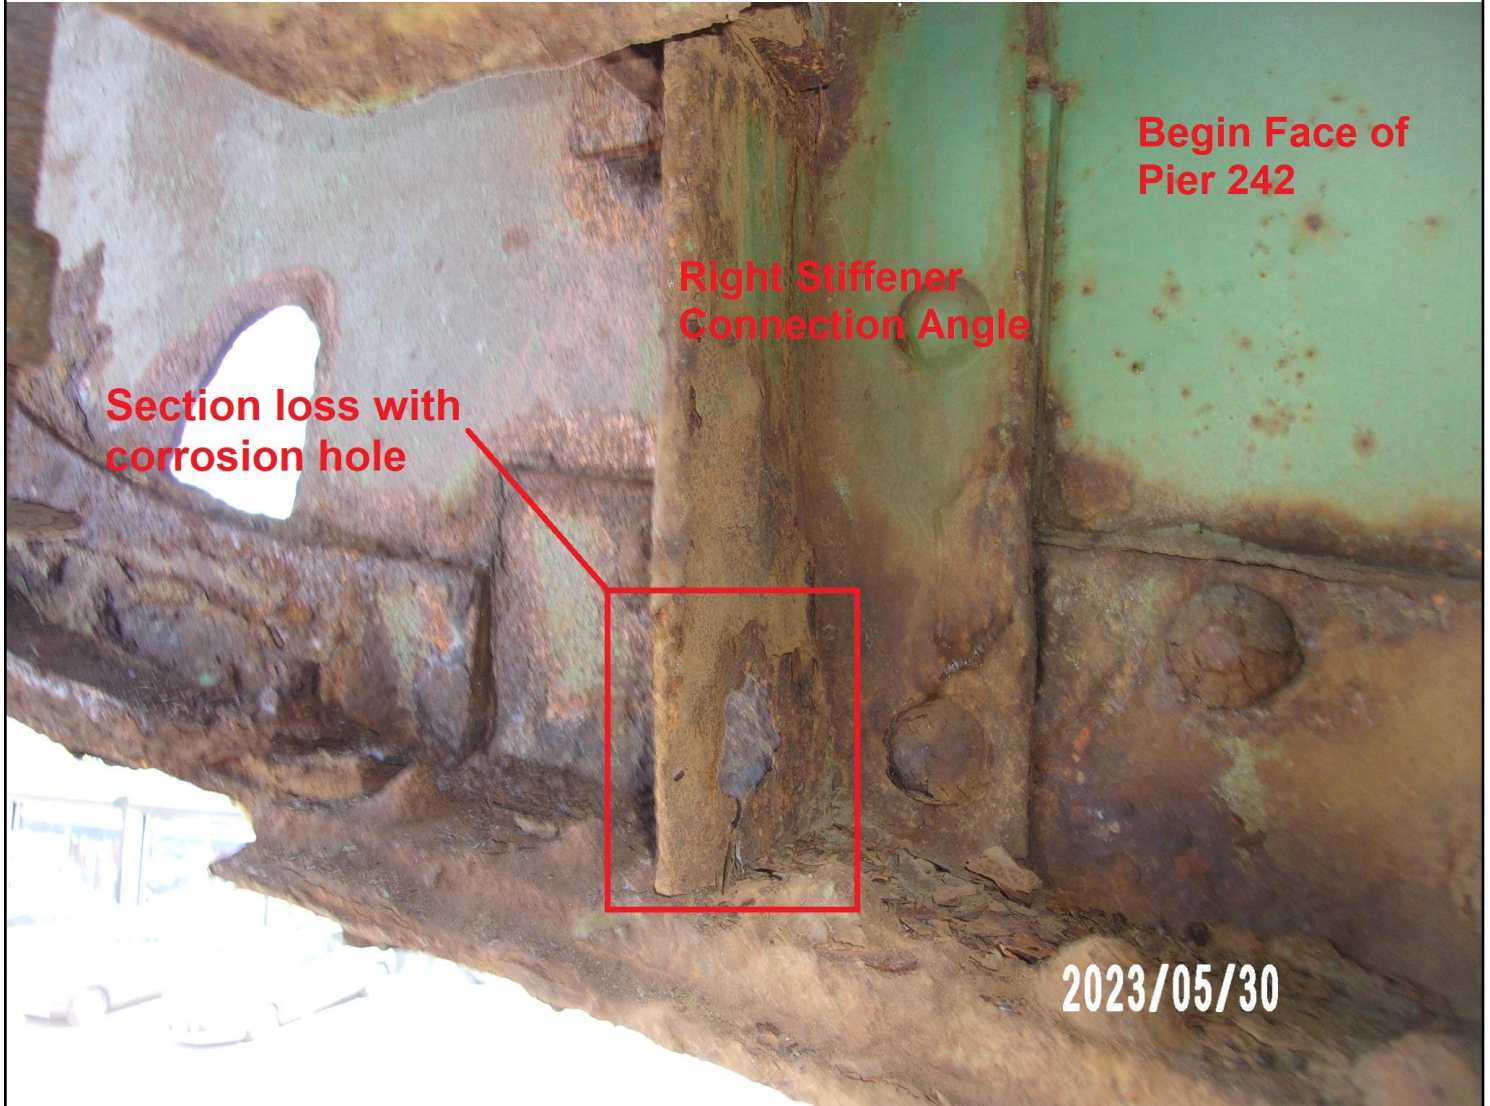
Photo Number: 10

Attachment Description: The base of the right stiffener connection angle at Girder G1 in Span 242 at Pier 242. The base of the stiffener connection angle exhibits 2-1/4"H x 2"L corrosion hole with up to 40% section loss. Looking End and Left.
